**Flood Control Project Maintenance
Levee Inspections**

Maintenance Issue Types Only, Levee Inspection Report By Mile - Fall 2016

Reclamation District No. 2058 Pescadero

Waterway	Bank	Unit Miles	Inspection Start/End	Inspector
Unit No. 01 Paradise Cut	Left	6.58	10/18/2016 10/18/2016	Maksim Khashchuk

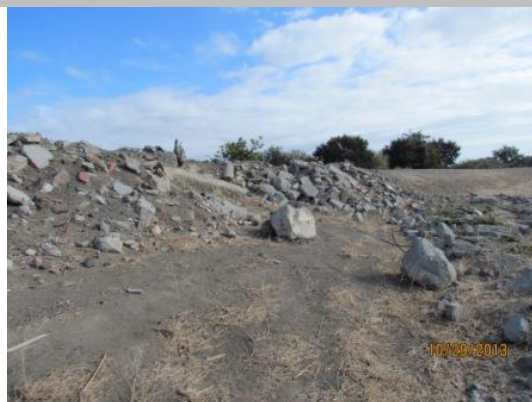
Photo 1 of 1 : FA_2016_RD2058_111_11_20160914_00005.jpg

LM Start	1.82	Rating **	U	Issue No.	11
LM End	1.83	Issue Type +	Ma	Location *	LS
Category	Earthen Levee			GPS Latitude/Longitude	
				Start	End
Item	Encroachments			37.804785 °	37.804802 °
				-121.391524 °	-121.391304 °
DWR ID	DWR_RD2058_01_f_2013_11				
Comment Code					
MA : Material					
Inspector Comment					
Pile of concrete contains rebar on landside slope obstructing visibility and access.

View of the concrete with rebar placed on the landside slope.

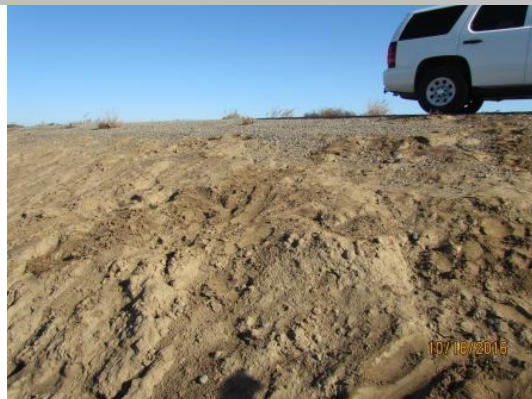
Photo 1 of 1 : FA_2016_RD2058_111_28_20161024_00046.jpg

LM Start	5.97	Rating **	M	Issue No.	28
LM End	5.97	Issue Type +	Ma	Location *	LS
Category	Earthen Levee			GPS Latitude/Longitude	
				Start	End
Item	Animal Control			37.774886°	37.774886°
				-121.335122°	-121.335122°
DWR ID	DWR_RD2058_01_s_2016_28				
Comment Code					
A3 : No rodents visible, but rodent burrows visible; need to backfill and compact or grout burrows.					
Inspector Comment

View of the rodent holes on the levee slope.

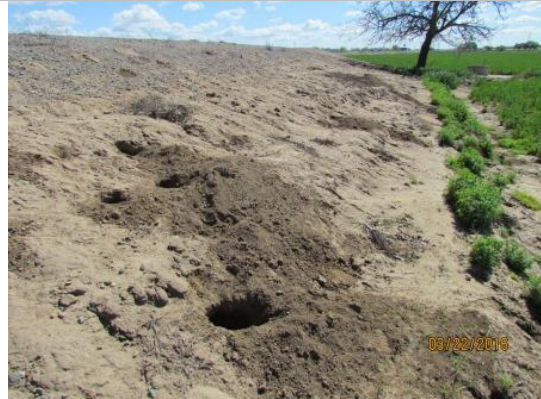
Photo 1 of 1 : FA_2016_RD2058_111_27_20160914_00012.jpg

LM Start	6.09	Rating **	A/W	Issue No.	27
LM End	6.10	Issue Type +	Ma	Location *	LS
Category	Earthen Levee			GPS Latitude/Longitude	
				Start	End
Item	Animal Control			37.773629 °	37.773503 °
				-121.333688 °	-121.333550 °
DWR ID	DWR_RD2058_01_s_2016_27				
Comment Code					
A3 : No rodents visible, but rodent burrows visible; need to backfill and compact or grout burrows.					
Inspector Comment					
LMA backfilled the rodent holes.

View of the rodent burrows on the landside levee slope.

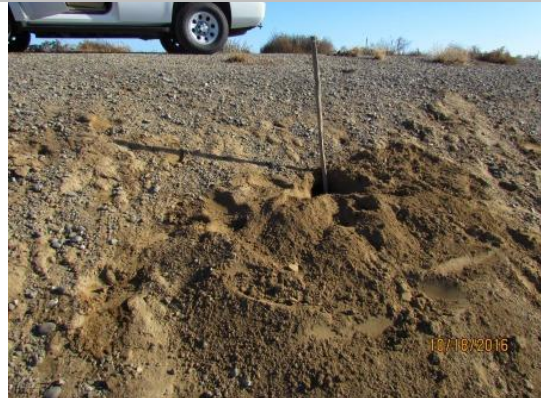
Photo 1 of 1 : FA_2016_RD2058_111_23_20161024_00041.jpg

LM Start	6.15	Rating **	M	Issue No.	23
LM End	6.15	Issue Type +	Ma	Location *	LS
Category	Earthen Levee			GPS Latitude/Longitude	
				Start	End
Item	Animal Control			37.773124°	37.773124°
				-121.332850°	-121.332850°
DWR ID	DWR_RD2058_01_f_2016_23				
Comment Code					
A3 : No rodents visible, but rodent burrows visible; need to backfill and compact or grout burrows.					
Inspector Comment

View of the rodent hole on the landside levee slope.
